# MASTERARBEIT / MASTER'S THESIS

„The Stratigraphy of the Hermitage on the Falkenstein“

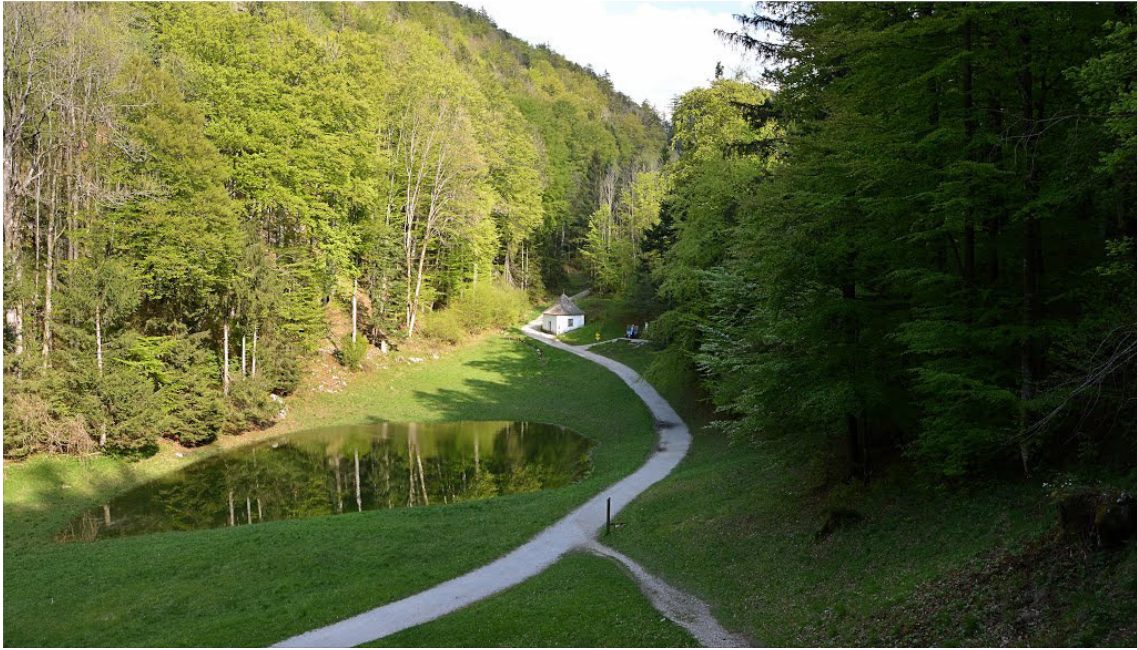
Fig. 2.4: Clearing at the Falkenstein after rain seen from the Falkensteinkirche (looking southeast).<sup>22</sup>

data; it is best visible in slope and contour visualization. Observations show that this depression fills with water after heavy rains and drains very slowly (Fig.2.4). This closed depression is a shallow basin with an ellipsoid shape and shallow floor, measuring about 50 x 30 m. As the whole area is prone to karst formation, the depression is most likely part of it, especially in the area where a fault can be expected.

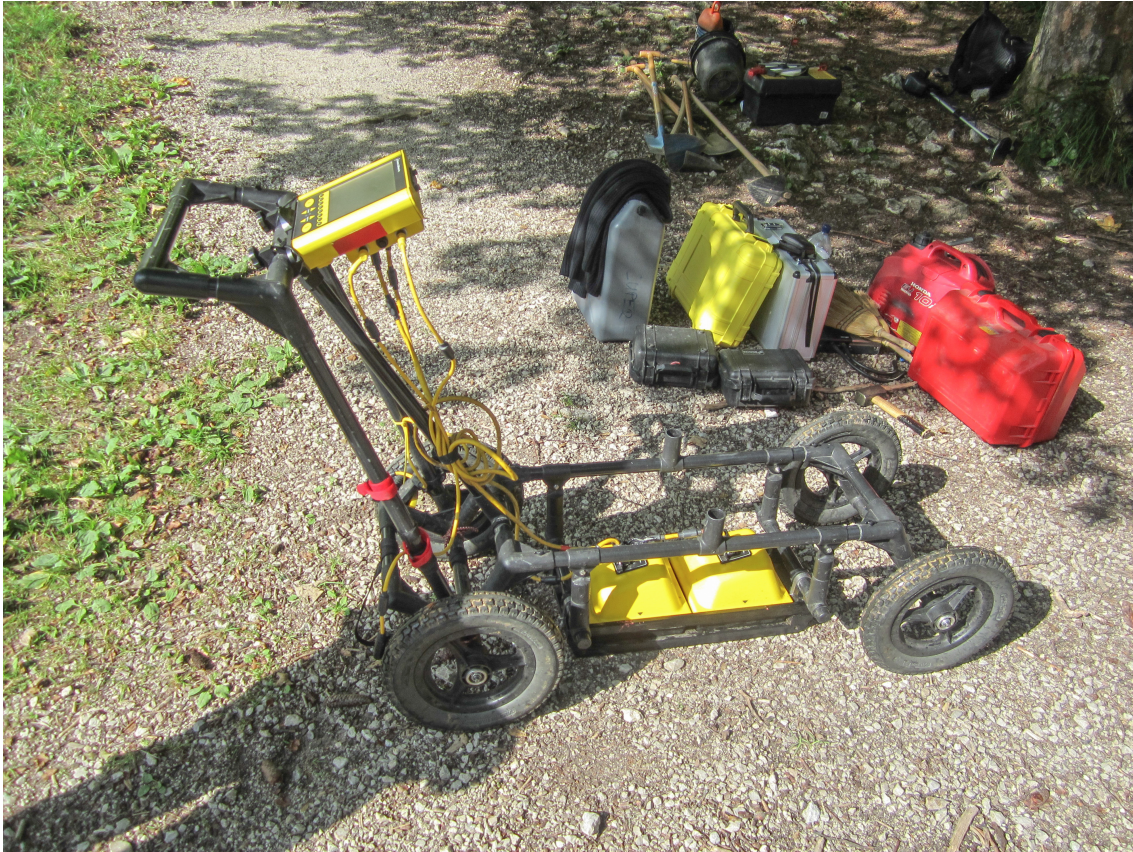
Fig. 4.1: A 500 MHz Tx-Rx antenna from PulseEKKO® PRO system of Sensors & Software mounted on a SmartCart.

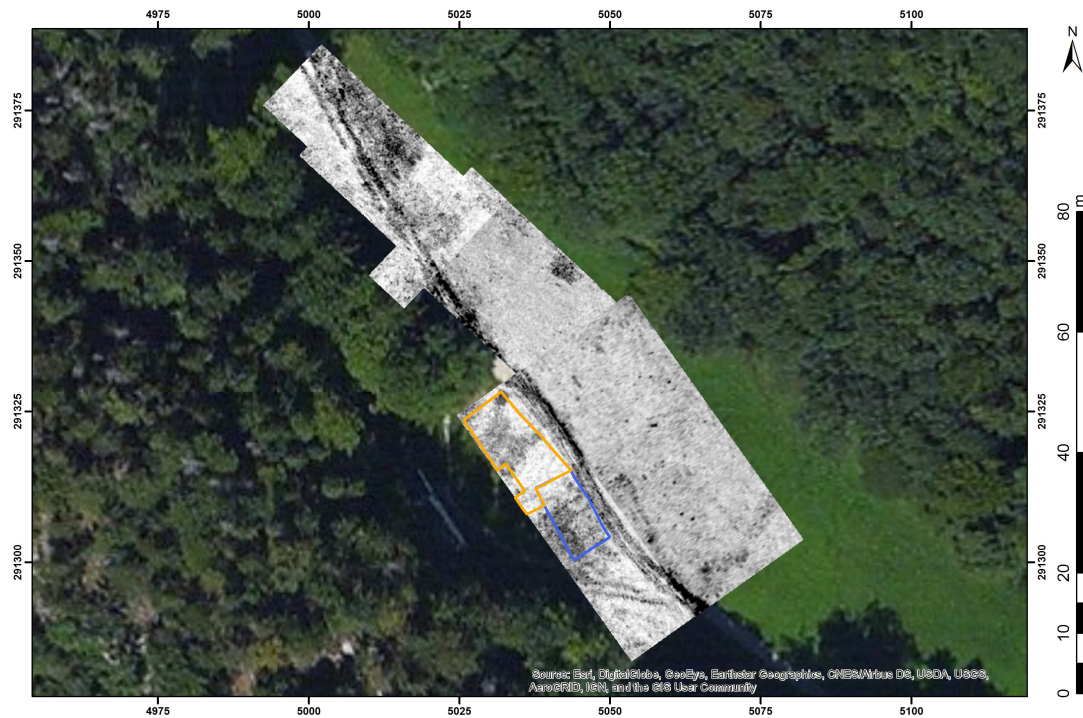
Fig. 4.2: Areas measured with GPR in 2009 and 2011 on the Falkenstein with the excavation areas 2011 (blue) and 2012 (orange).

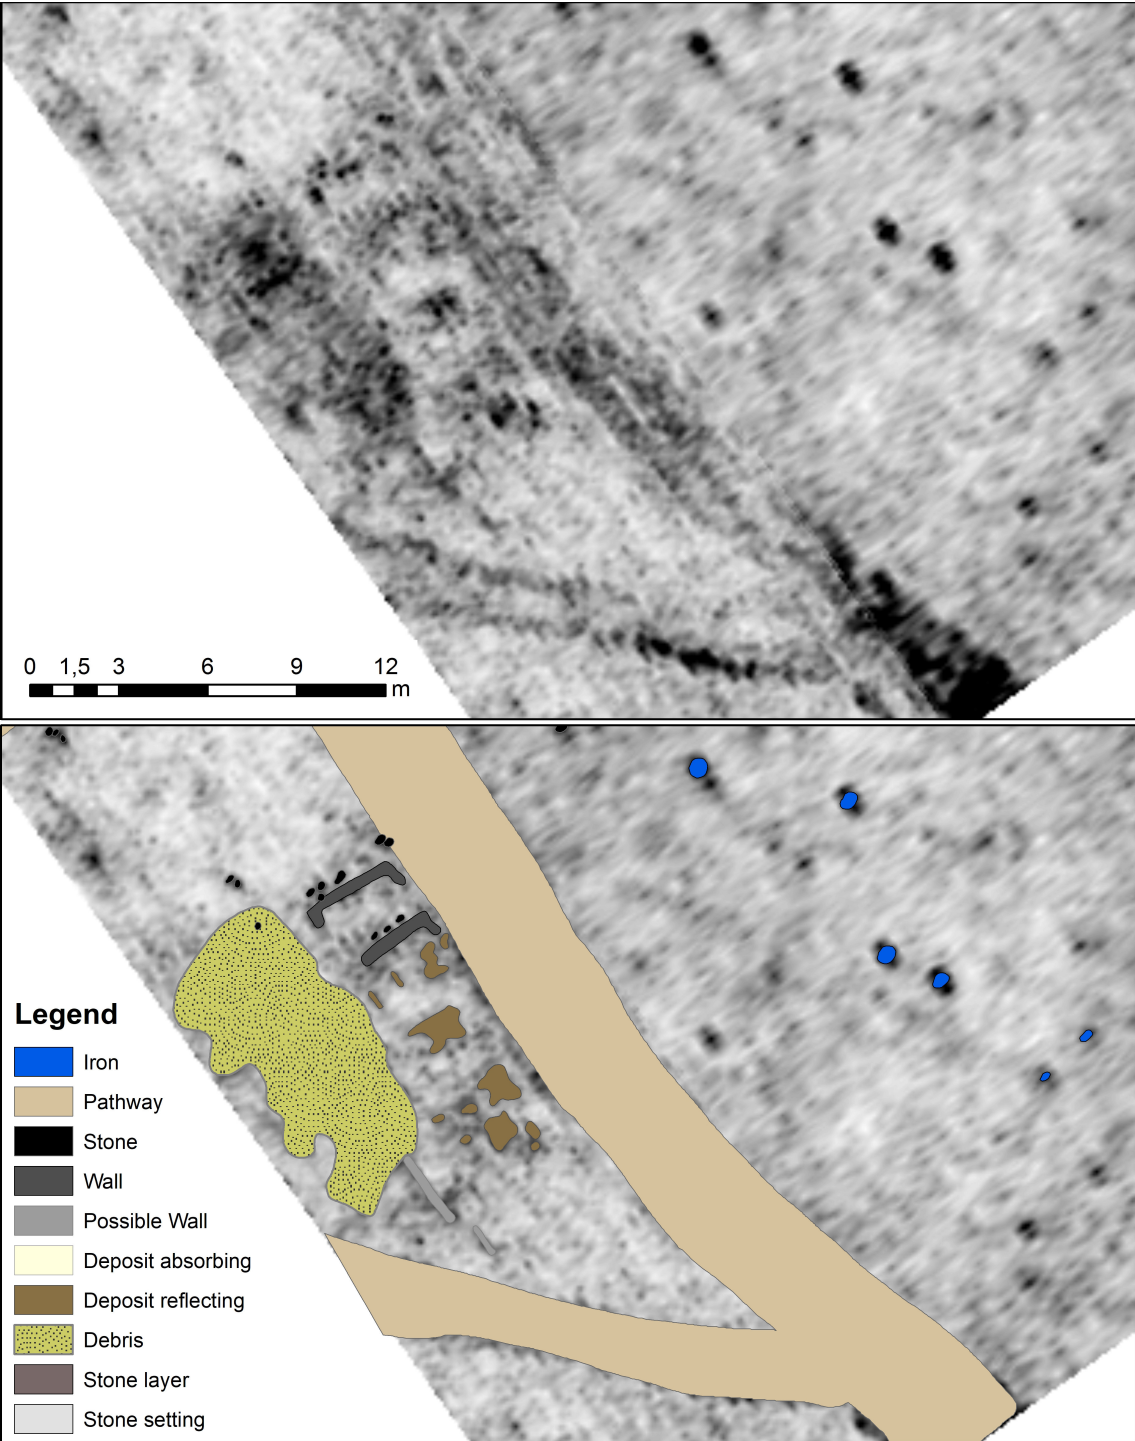
Fig. 4.3: Depth slice (top) and interpretation map (bottom) from 0-20 cm.

In the upper 20 centimeters (Fig.4.3), an elongated reflective linear feature running from northwest to southeast can be easily attributed to the current path. In the northwestern corner of the prospected area, rock or loose material is visible as a reflective feature with a half ellipsoid shape. A little to the southeast, a distinctive

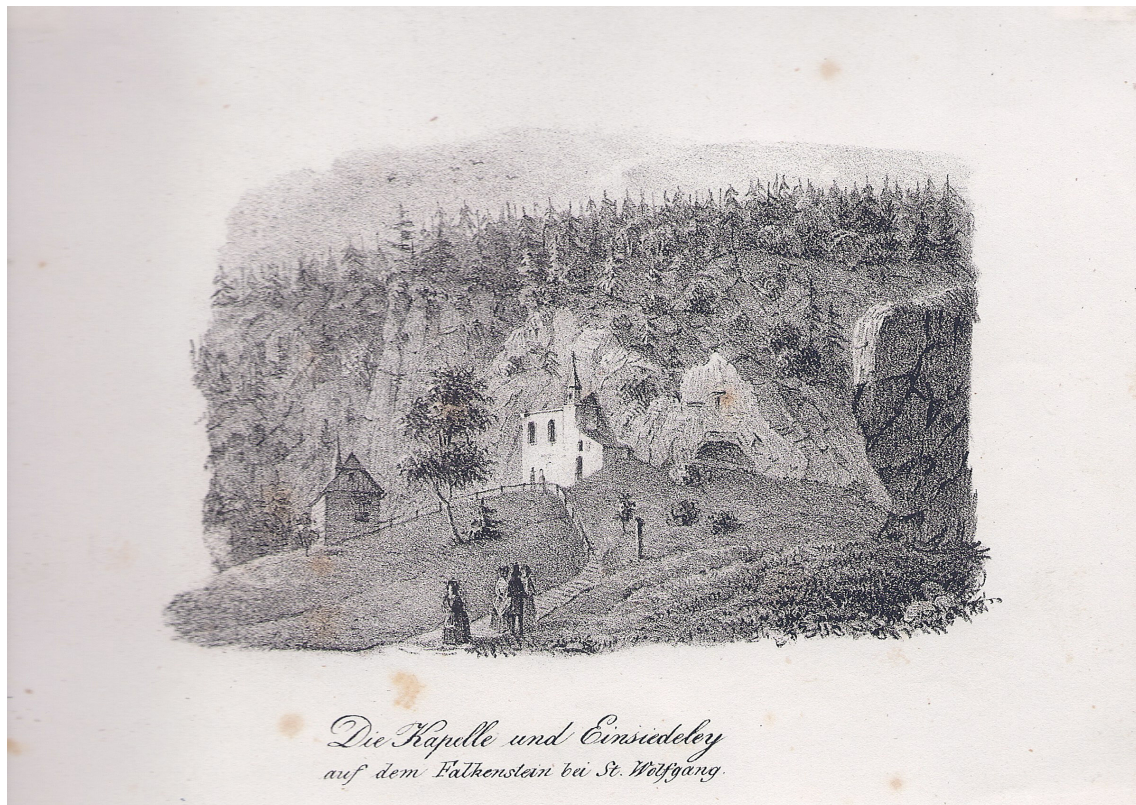
Fig. 4.11: The chapel and the hermitage on the Falkenstein near St. Wolfgang, drawing from around 1800.

Another depiction from an unknown artist from around 1800 seems to be showing a wooden building (Fig. 4.11). The hermitage is depicted from the north (or NNO). The two-storied building is oriented NNW-SSE. The relationship of the chapel beneath the visible tower to the main building cannot be seen from this perspective. An oil painting in the Quellkapelle by Wolfgang Spieß from the second quarter of the 18th century shows an NW-SE-oriented building with two stories and a possible attic (Fig. 4.12). A tower of the supposed chapel is visible at the SW-end. The painting shows the clearing from the northeast – therefore, it is impossible to make a statement about the chapel's constructional relation and the hermitage's main building.

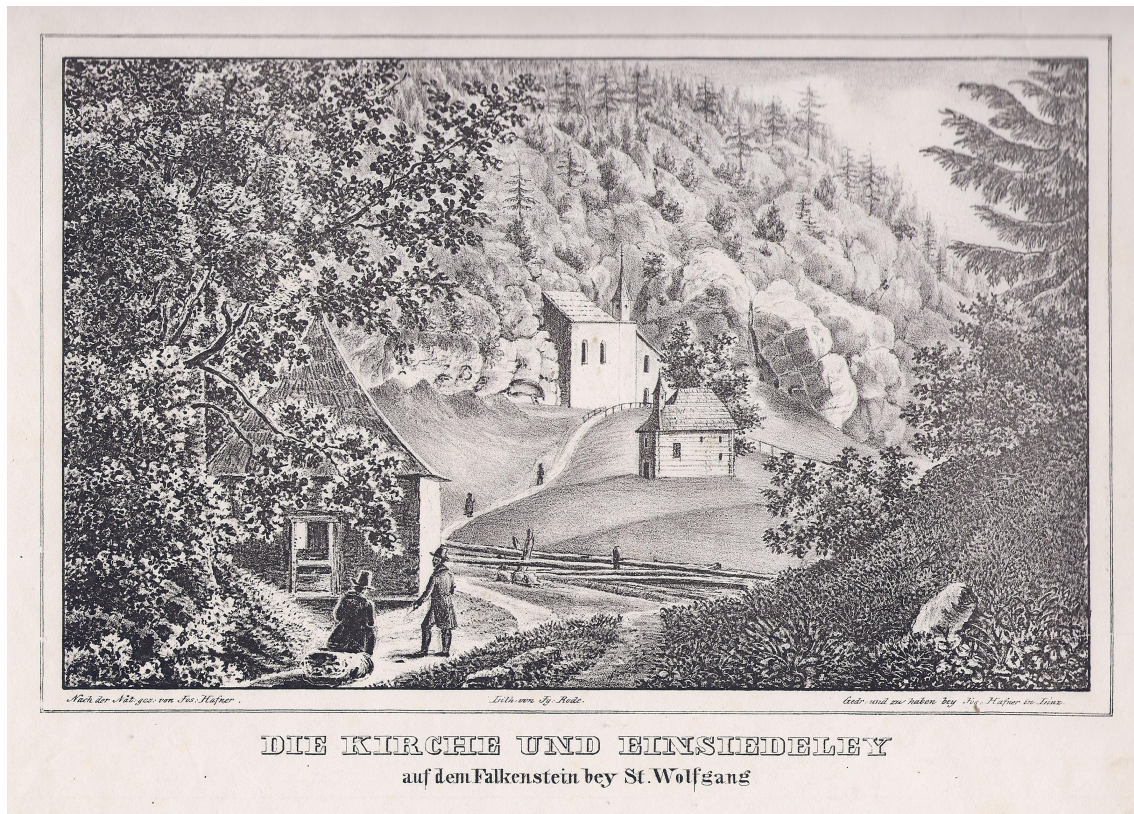
Fig. 4.14: The church and the hermitage on the Falkenstein near St. Wolfgang - engraving by Ignaz von Rode (1819-1859) after a drawing of Josef Hafner (1799-1891) from between 1829 and latest 1835.

Another engraving, done by Ignaz von Rode (1819-1859) after a drawing of Josef Hafner (1799-1891) from, at the latest, 1835 – again shows an NNW-SSO oriented wooden building with two stories, where the northern part resembling a chapel and the hermitage form an entity (Fig. 4.14).

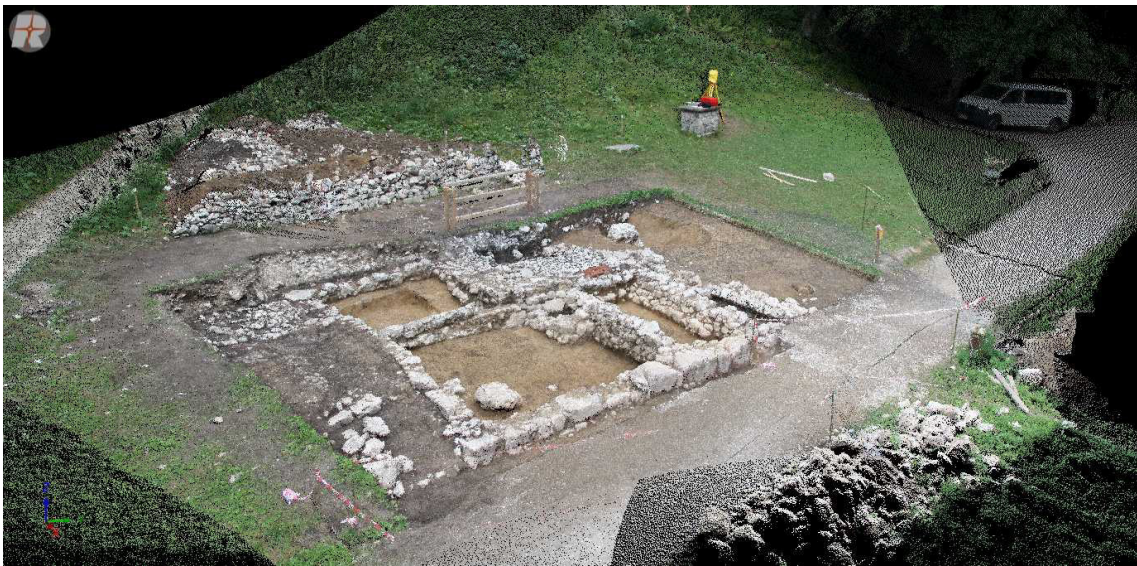
Fig. 4.24: Colored point clouds were gathered with the LMS-Z420i.

The used TLS, LMS-Z420i, is manufactured by Riegl (Riegl LMS GmbH 2010) and is a pulsed time-of-flight laser scanner<sup>146</sup>. Nowadays a newer model is in use. The primary data obtained in the field are XYZ coordinates, which are visualized as high-resolution 3D point clouds with RGB values (Fig. 4.24).

Besides the 3D coordinates, the data stream contains each point's signal amplitude, range, and angle in a relative coordinate system (Scanner Own Coordinate System = SOCS). The used system has an accuracy of  $\pm 1\text{cm}$ . Its vertical scanning range is up to  $80^\circ$  while the horizontal scanning range is  $360^\circ$ . The angular step width can be chosen between  $0,004^\circ \leq \Delta\delta \leq 0,2^\circ$  in vertical and  $0,004^\circ \leq \Delta\phi \leq 0,75^\circ$  in horizontal direction. The actual resolution depends on the distance to the measured surface. The distance measurement (range up to 1000 m) is calculated from the travel time of the laser pulse between signal transmission and reception.

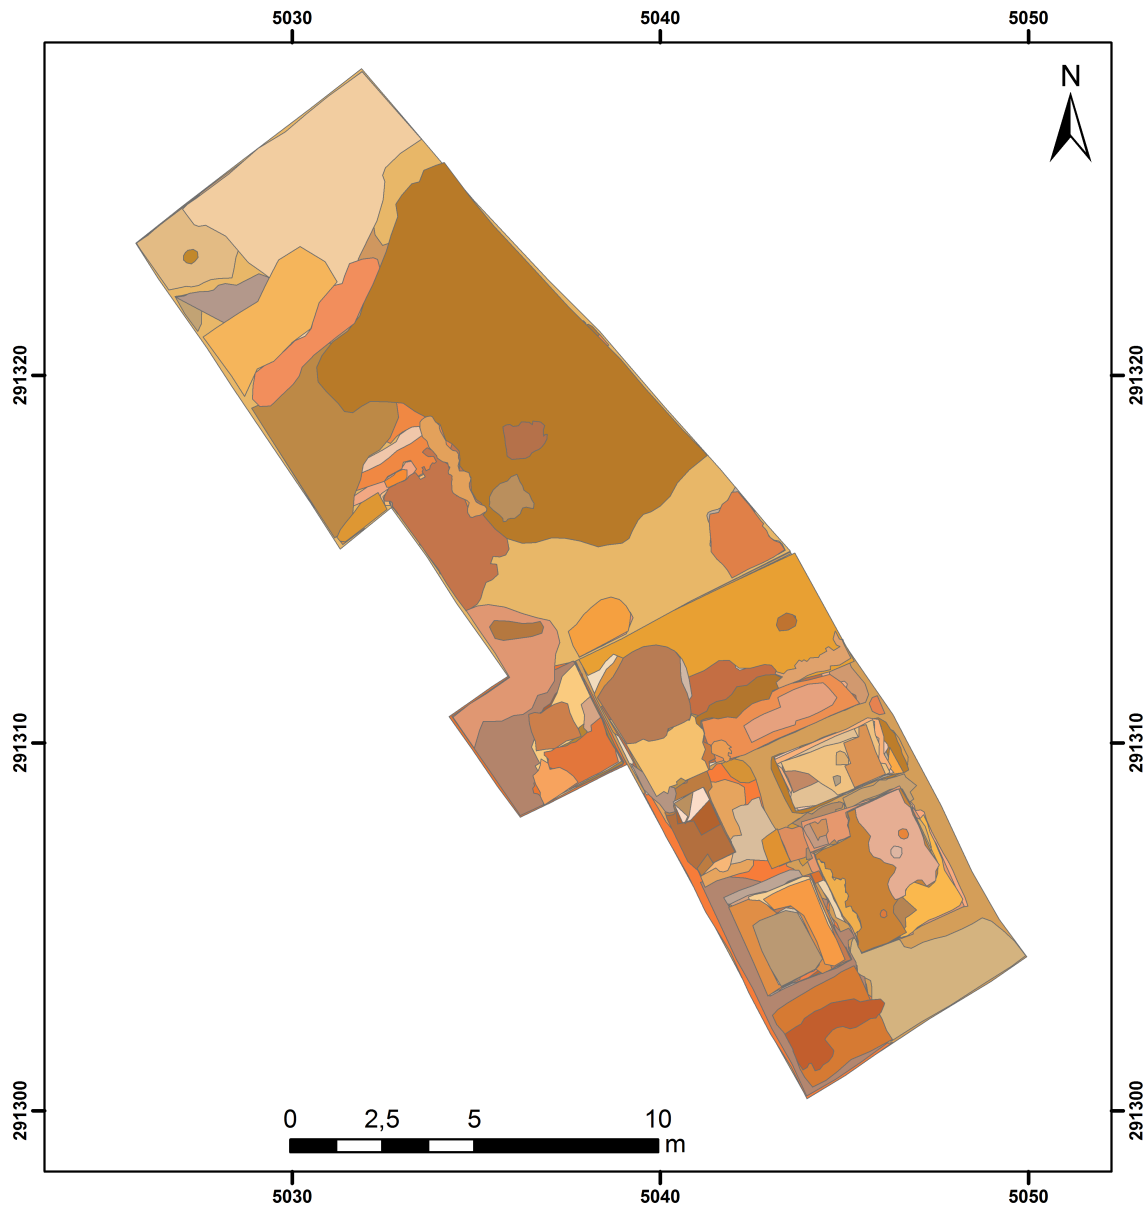
Fig. 5.1: Overview of all stratigraphic units from the excavation campaigns 2011/2012; the polygons are the visualization of the recorded total station data; the order of visualization does not represent the stratigraphic sequence of the deposits.

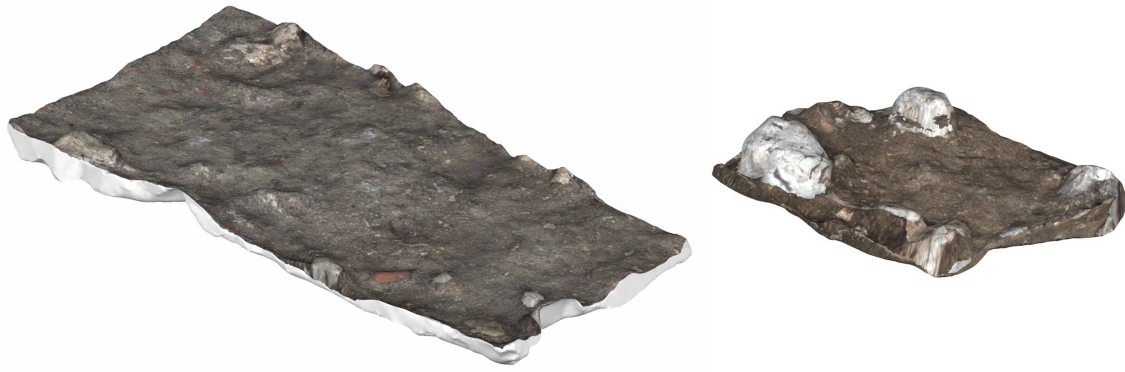
Fig. 5.9: Textured flat (left) vs. textured complex surface (right) colored from only one image.

The outcome highly depends on the mesh's surface and the photo's quality. As mentioned above (see 4.4), the photo documentation typically consisted of one photo of the deposit taken from above. Only some surfaces are documented with more photos for an image-based modeling approach. Flat surfaces are logically easier to texture with one 2D image than more complex surfaces (Fig. 5.9). The outcome for flat surfaces is accordingly better, resulting in qualitative textured 3D surfaces. The results for the more complex surfaces – e.g., stone layers – are quite poor and need another approach.<sup>156</sup>

For this purpose, the top surfaces are exported from Geomagic Studio as .obj for texturing in Agisoft Photoscan. The photos were aligned in Agisoft Photoscan, and instead of creating a mesh (model) in the same software, the mesh created from the TLS point cloud with Geomagic Studio is imported. The surface is textured based

on the alignment of the photos (in an object coordinate system; ground control points are transformed before referencing in Agisoft Photoscan). This results in a qualitative texture of every surface. This approach combining Geomagic Studio and Agisoft Photoscan for texturing 3D archaeological surfaces/volumes created with TLS-data was first used at the excavation of the gladiator school in Carnuntum in June 2014 after testing it on the data of the present master thesis. It was successfully used in the years afterward in Hornsburg, Rom (Schneidhofer et al. 2017), and Durrington Walls (Fig. 5.10).

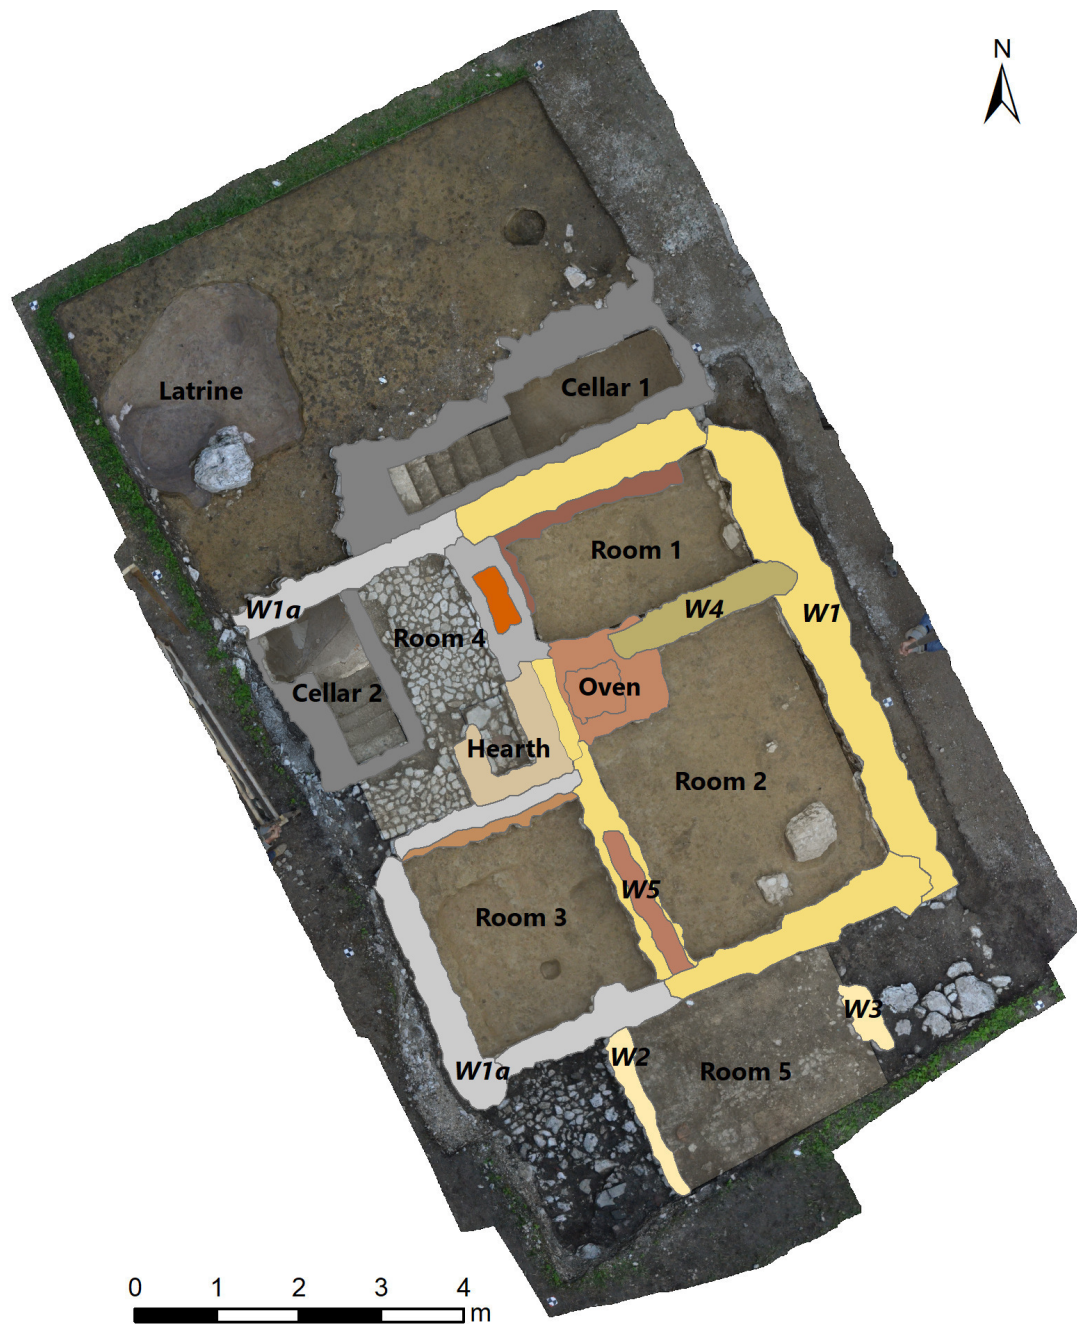
Fig. 6.1: Overview showing the floor plan and walls of the hermitage.

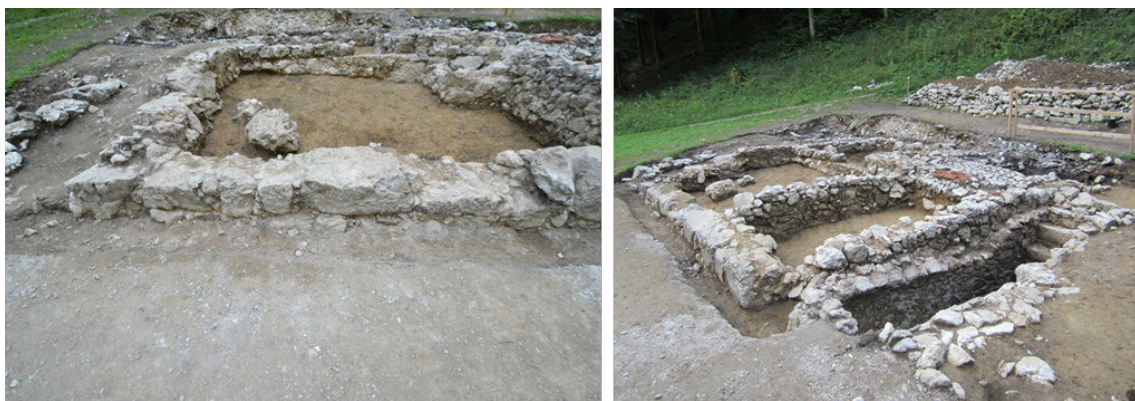
Fig. 6.2: Foundation Wall 1 building the outline of the hermitage.

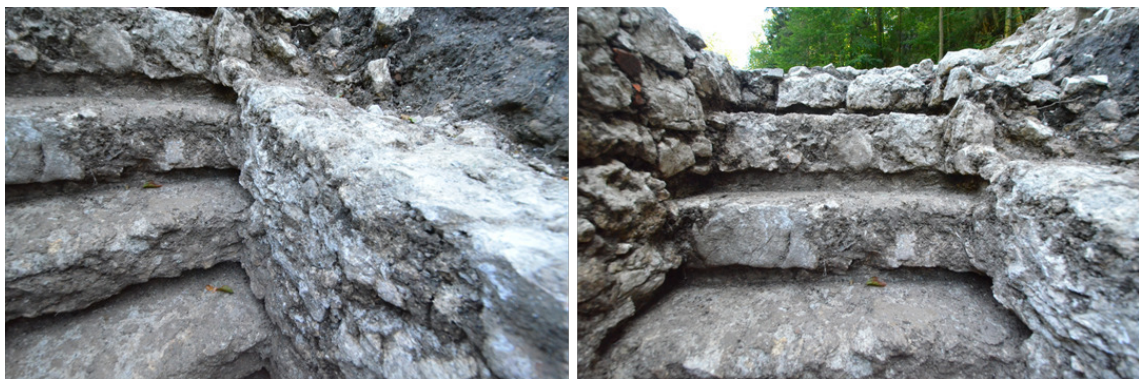
Fig. 6.6: Stairs with recesses for wooden covers in Cellar 2.

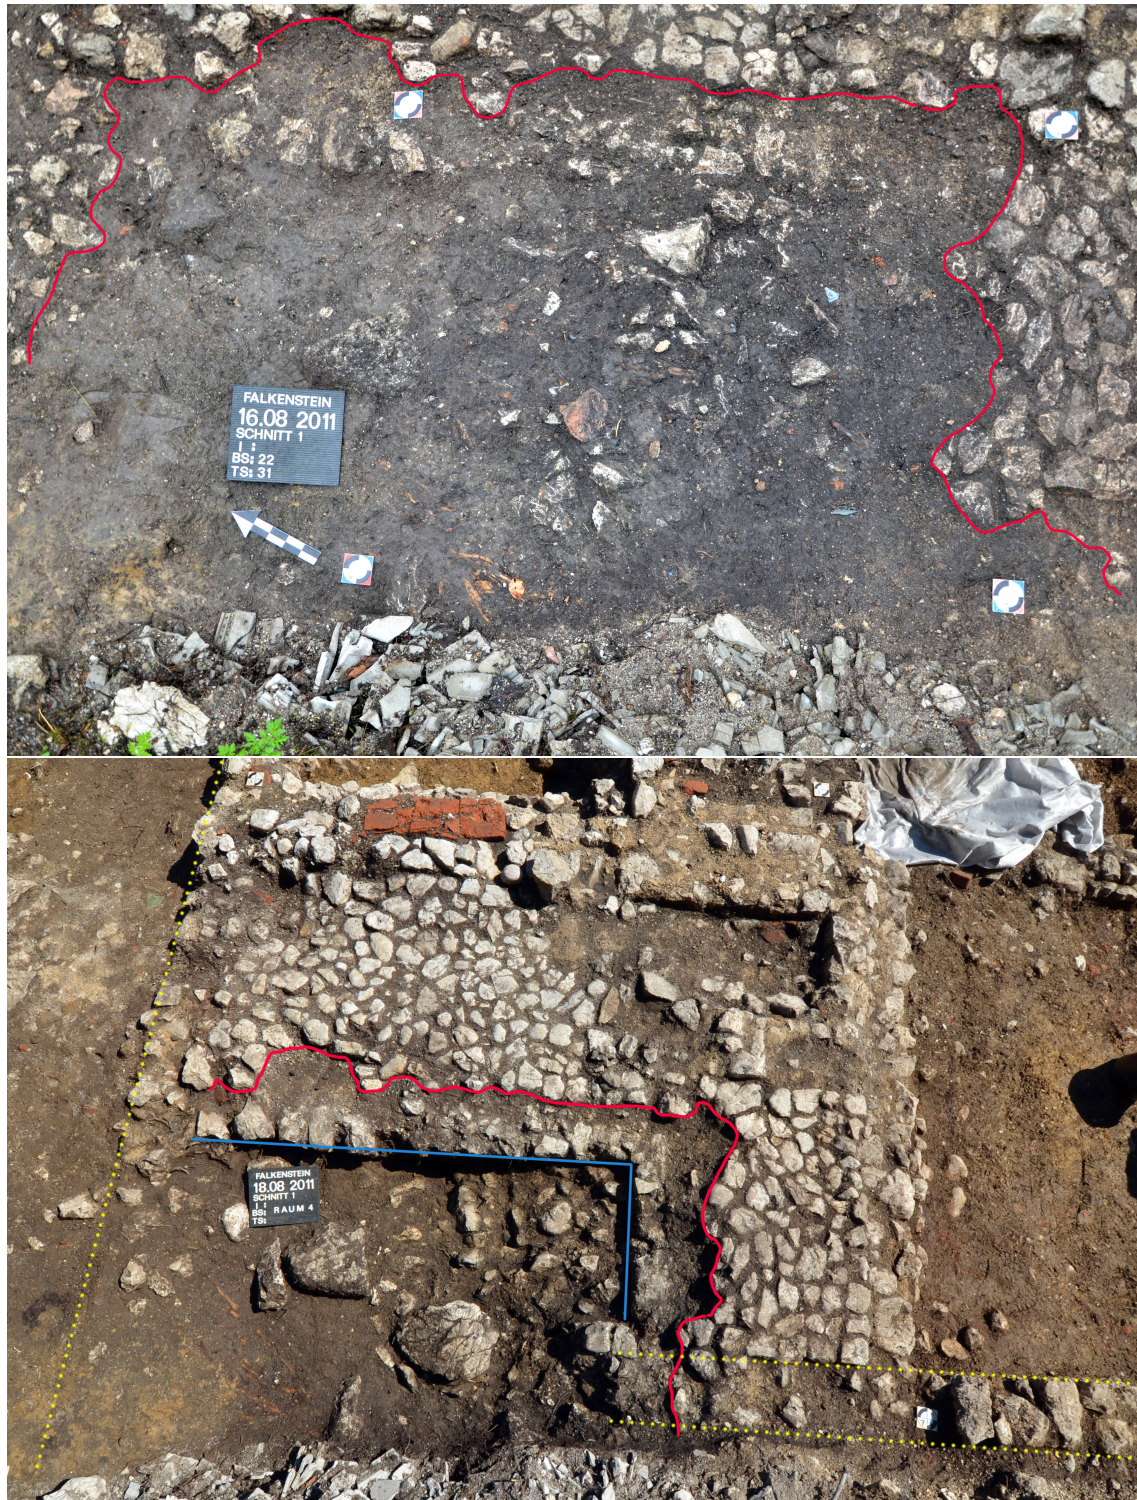
Fig. 6.7: Irregular edge (in red) of paving SU 41 in Room 4. Above: before removing SU 31; below: after totally exposing SU 41.

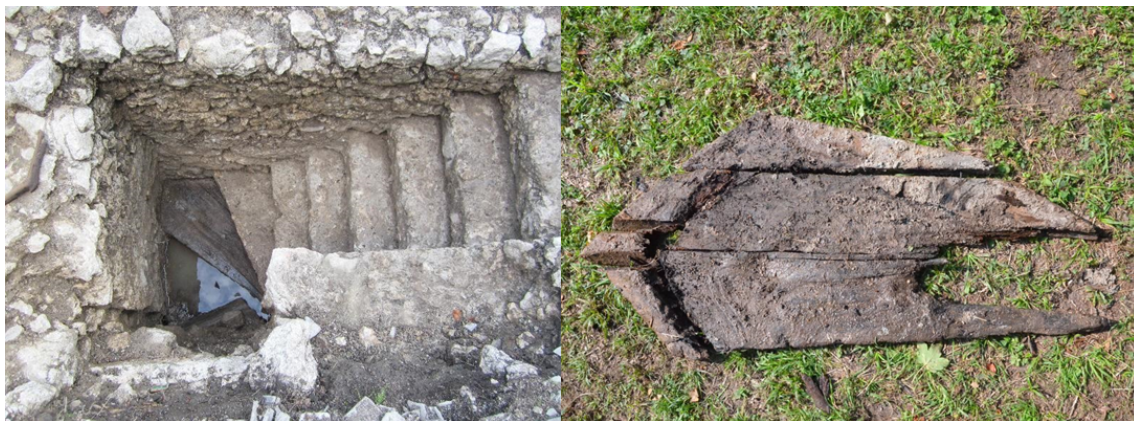
Fig. 6.8: Left: Wooden plank – deposit 114 - on the last step of the stair of Cellar 2. Right: Plank after recovery.

The steps executed in the masonry were covered with wooden planks. **Deposit 114** is the rest of the plank, which covered the last step (step eight) of the stairs (Fig. 6.7). The analysis of the wood carried out by the University of Natural Resources and Life Sciences (Vienna) identified the wooden fragments as oak. They could not be dated, but the report states a “non-significant evidence for the late 16th century”.<sup>169</sup> As the cellar was one of the first parts of the hermitage to be concluded, the “non-significant evidence” of the samples predate the historically recorded building date of 1659 by less than 100 years. The tree supplying the wood was most probably cut some years after the documented date, considering the missing wane. It is most likely that the wood has been used as the original planking in the construction of the cellar in 1659 after it had dried. The plank then remained in its place for the lifetime of the hermitage. The wooden planks are the level on which the cellar was used. Therefore, an interface of use (SU 113) was introduced, representing the time of use.

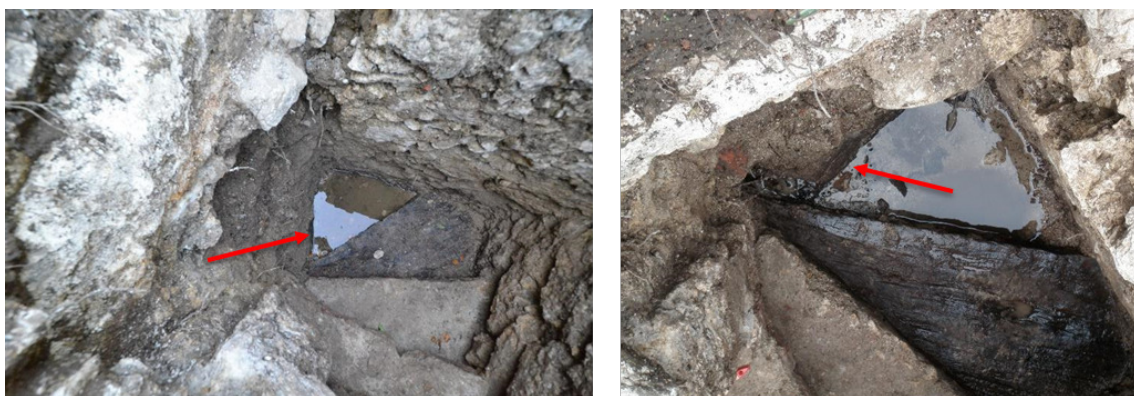
Fig. 6.9: Wooden pipe at the bottom of Cellar 2.

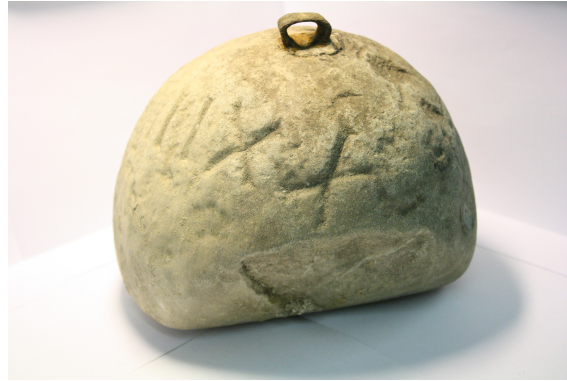
Fig. 6.10: Stone weight found in SU 95. It is about 20 cm in diameter and has the roman number XXIII encraved.

water stoup or baptismal font. The stone weight mentioned above as part of the counterweight system of the trap door is about 20 cm in diameter and has the shape of a hemisphere. Located on its top is a metal loop, allowing the attachment of the rope for the counterweight system for the trap door.

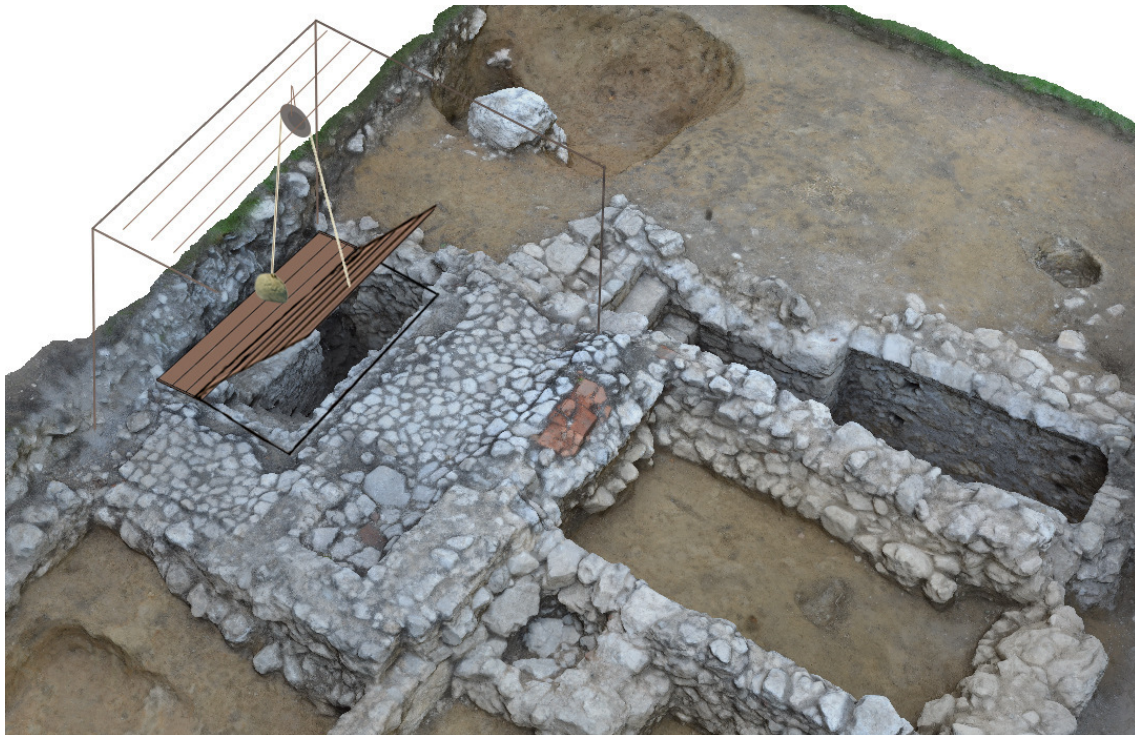
Fig. 6.11: Possible trap door covering Cellar 2. The found stone weight might have been part of a pulley system with a counterweight to operate the trap door.

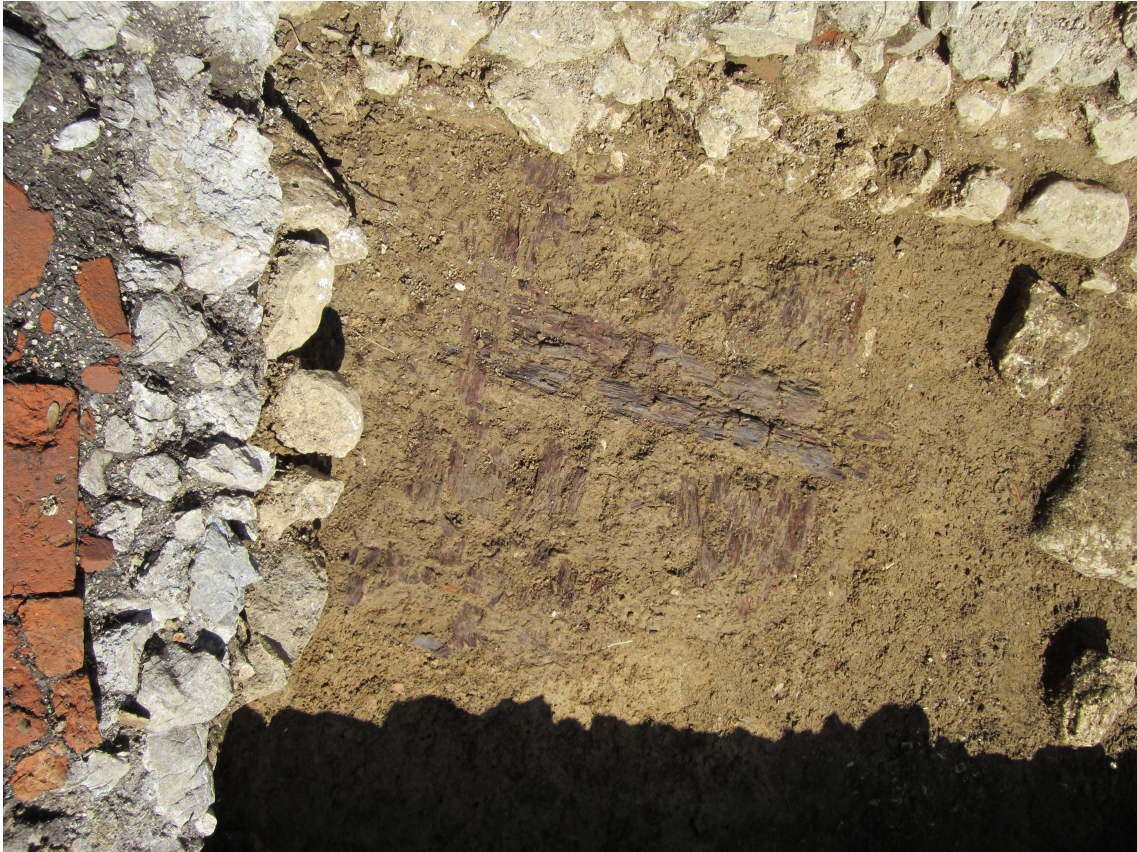
Fig. 6.17: Remains of a wooden floor SU 100 in Room 1.

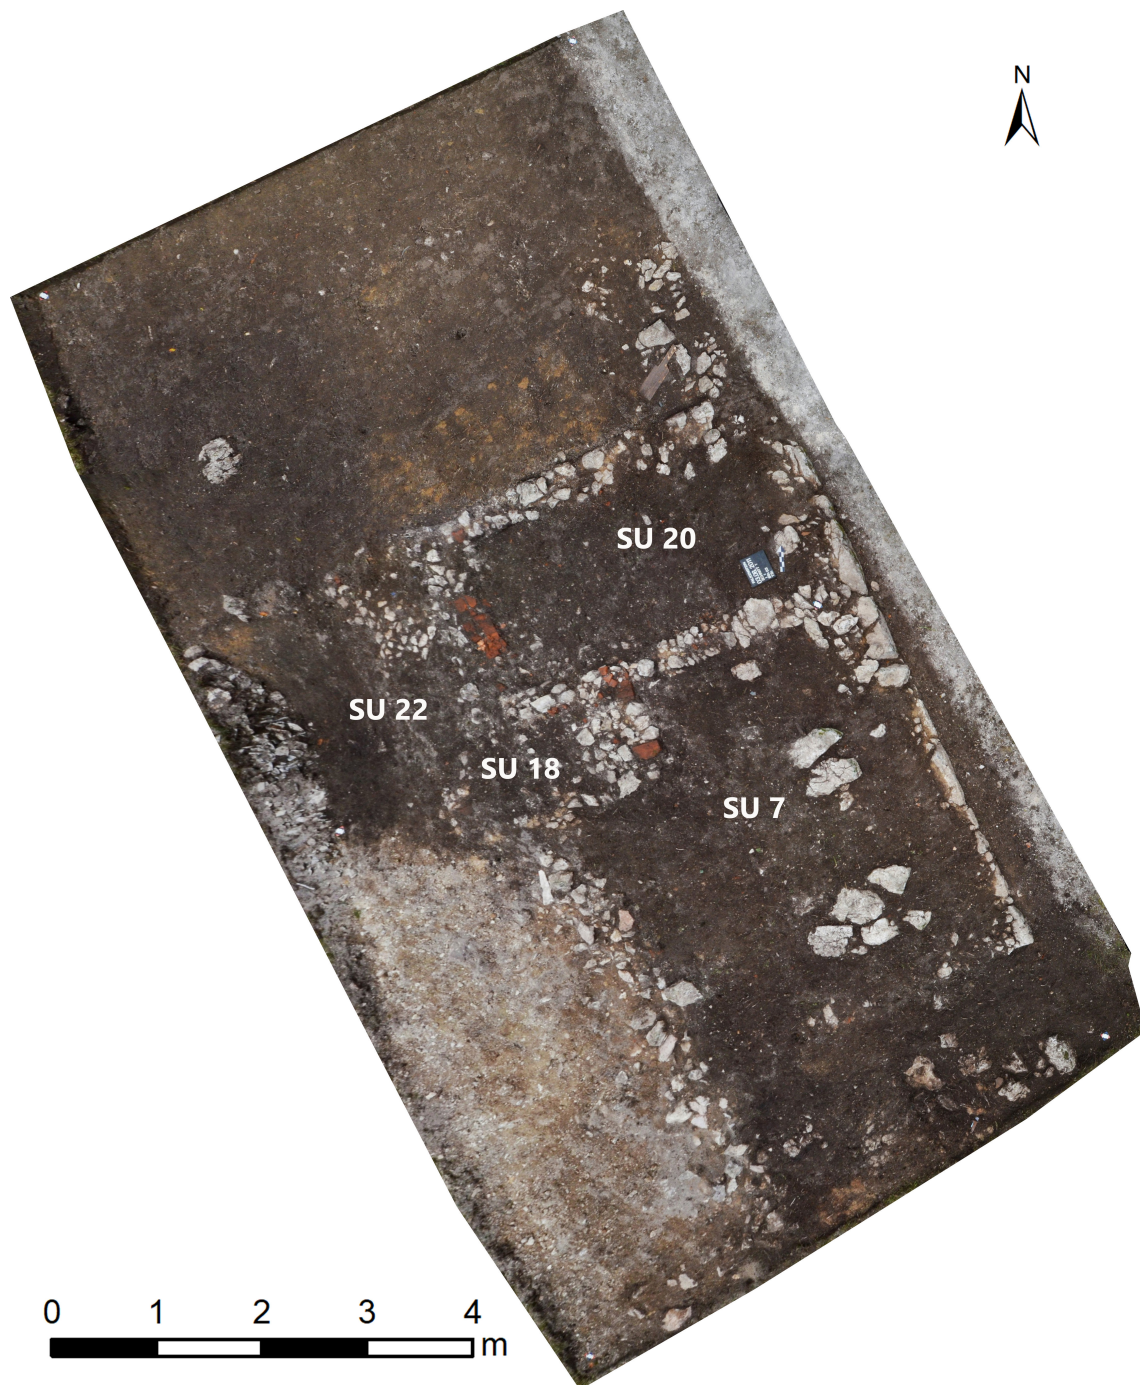
Fig. 6.18: SU 20 in the north, enclosed by Walls 1 and 4, SU 7 below, SU 18 in the center (above the oven), SU 22 right on the left of SU 18.

Loose brownish-black clayey silt with 15 % of little pebbles (2-6,3 mm), brick and wall debris, and pottery are defined as **deposit 20**. The photo evidences a darker brown deposit in the eastern third of the room and the same dark brown sediment with more grayish inclusions in the west. Visually the latter seems like the sediment of SU 7 in Room 2, SU 18 (above the oven), and SU 22 in Room 4 (see Fig. 6.18). It is interpreted as intentional filling of the room to level the ground for another purpose after the use time of the hermitage. The finds represent a wide range of discarded materials (see table 6.18).

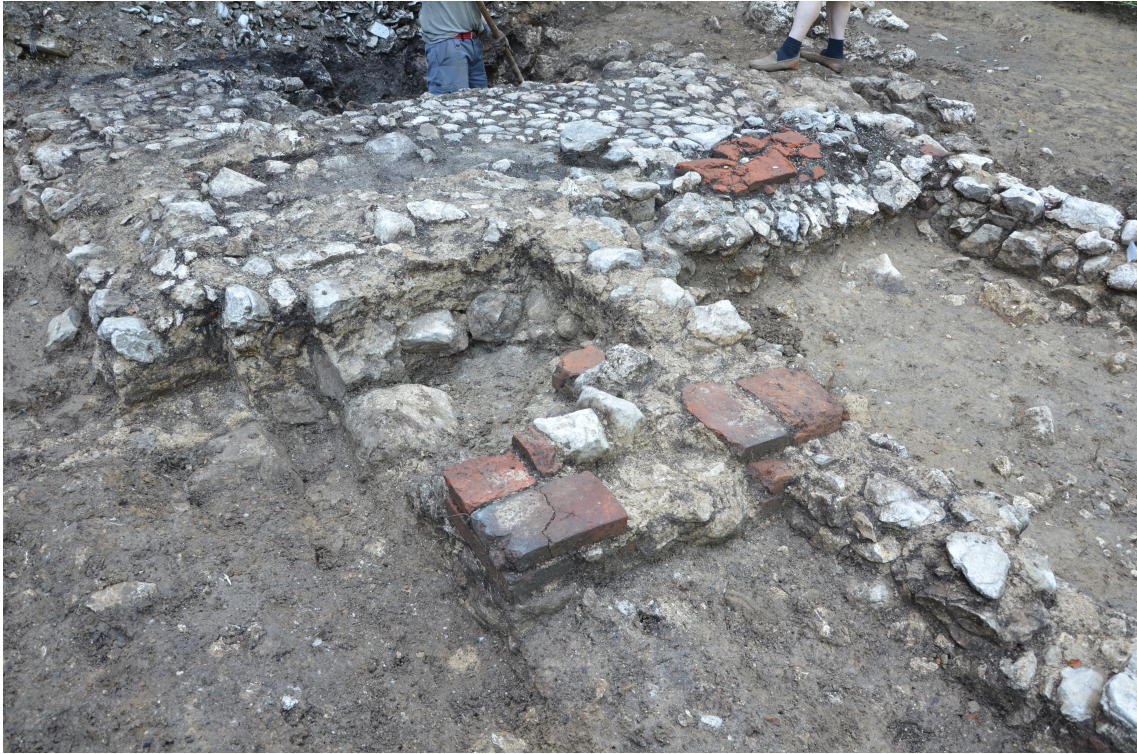
Fig. 6.20: Oven-hearth complex from the southeast.

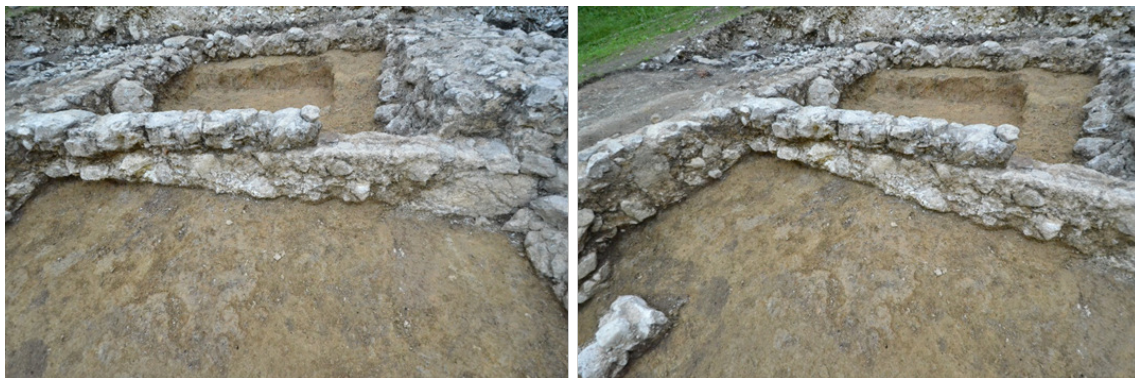
Fig. 6.22: Wall 5 between Room 2 and Room 3 built atop Wall 1.

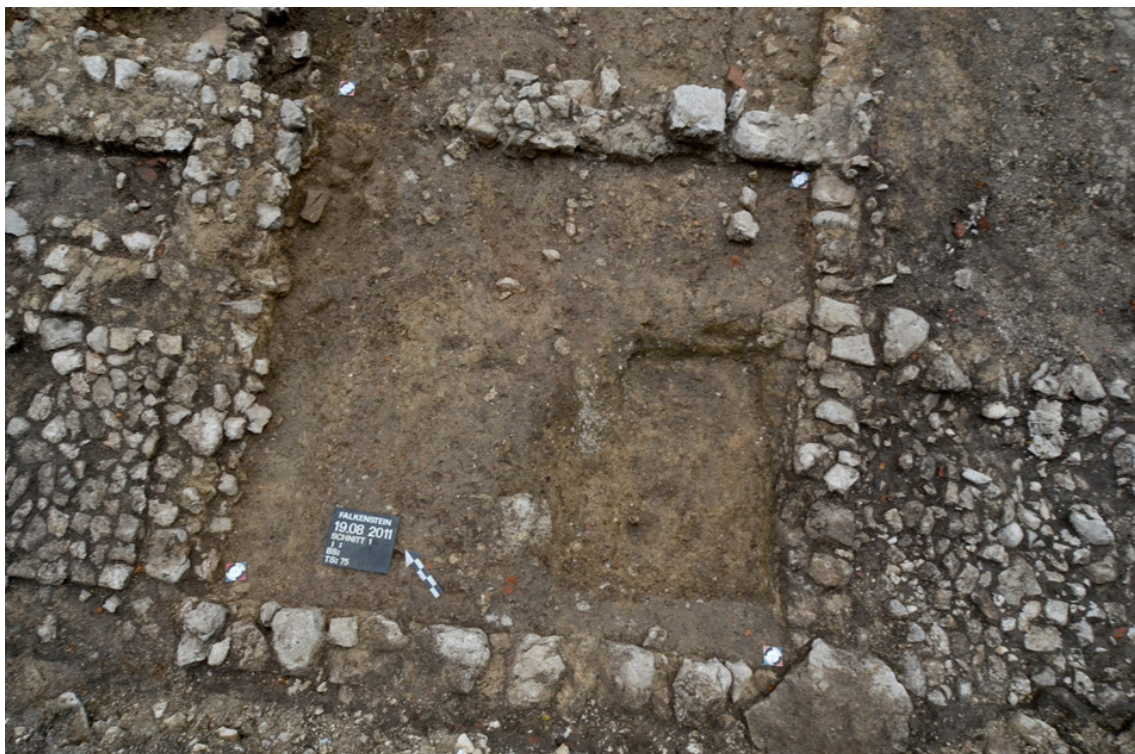
Fig. 6.24: SU 75 and SU 251.

A brighter yellowish area can be distinguished from darker sediment alongside the eastern wall (W5) and the northern wall. A darker patch in the west of the proposed SU makes the distinction to the north in the very western part difficult.

SU 75, therefore, only comprises the darker sediment with stones alongside the eastern and northern wall (see Fig. 6.24), suggesting a cut with the extensions of

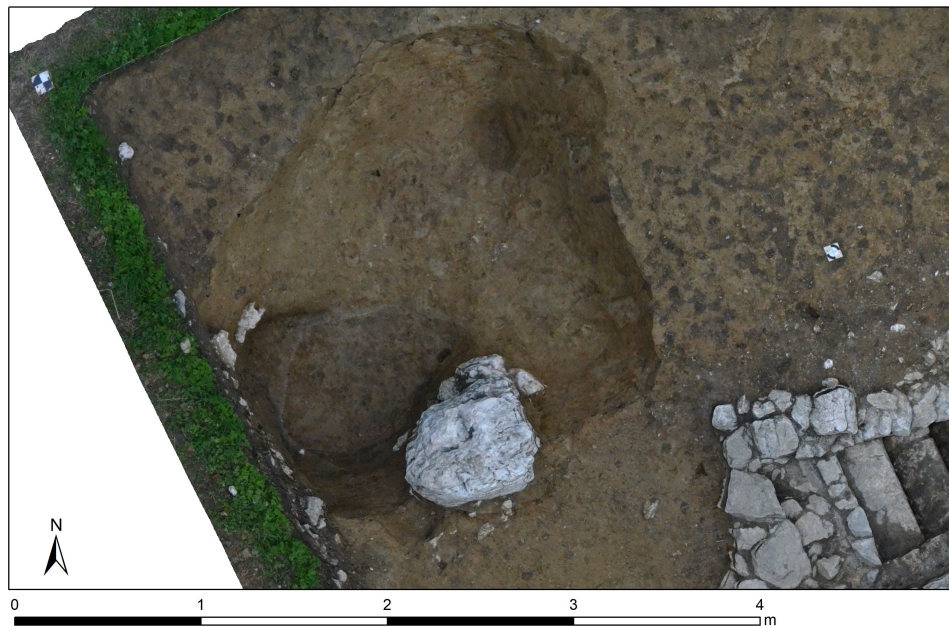
Fig. 6.26: Latrine pit in the northeast corner of the trench of 2011.

The pit in the northeast corner of the trench of 2011 was cut by its limits; the remaining part was excavated in 2012. The **interfaces (131, 249)** of the two parts of the pits can be correlated with certainty too. The interface of the pit seems to show a significant depth difference between 2011 and 2012 in the 3D-data – photographic data though evidence, that the deepest part of the pit is ending in a steep slope just a few centimeters east to the trench limits of 2011.
