# MASTERARBEIT / MASTER'S THESIS

„The Stratigraphy of the Hermitage on the Falkenstein“

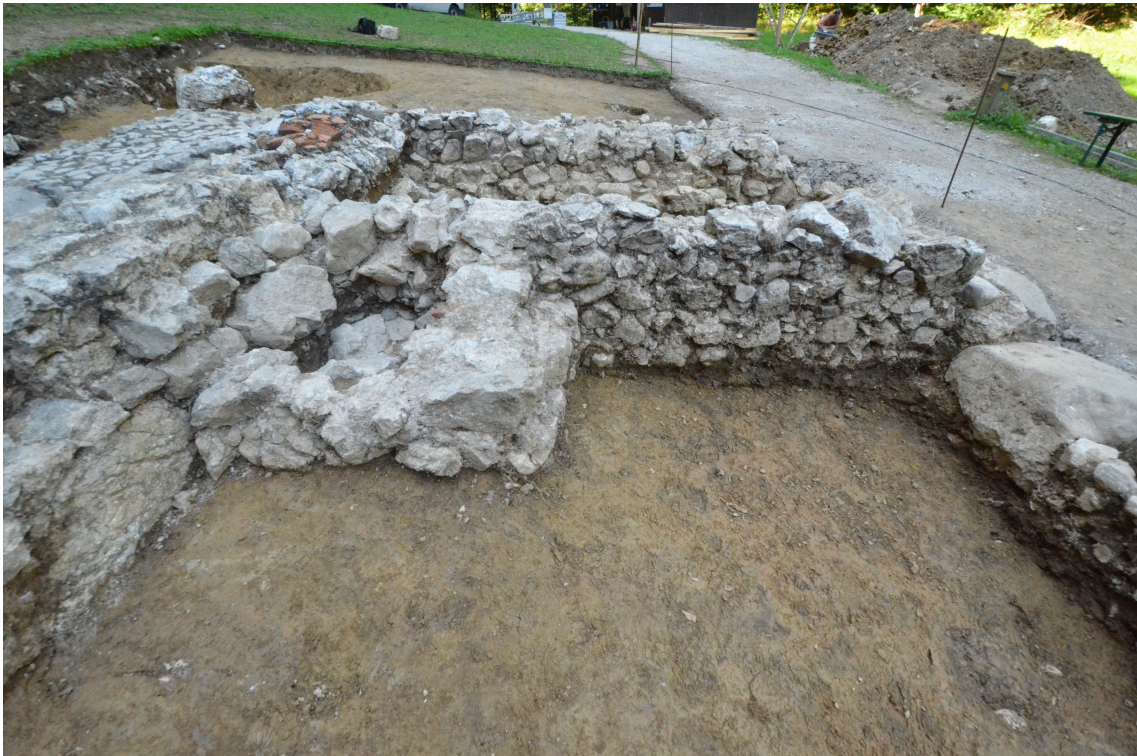
Fig. 7.2: Wall 4 on top of rests of SU 106/SU126 (in the right), leveling the ground to build it.

excavation show that Wall 4 is set above of darker material in the east. Therefore, it is assumed that the wall was built after leveling the underground inside of the surrounding wall M1 and that the deposits 126, 127, 106, 109, 115 are one continuous deposit. Supposedly the act of leveling the inside of M1 took place in the same construction event in 1659.

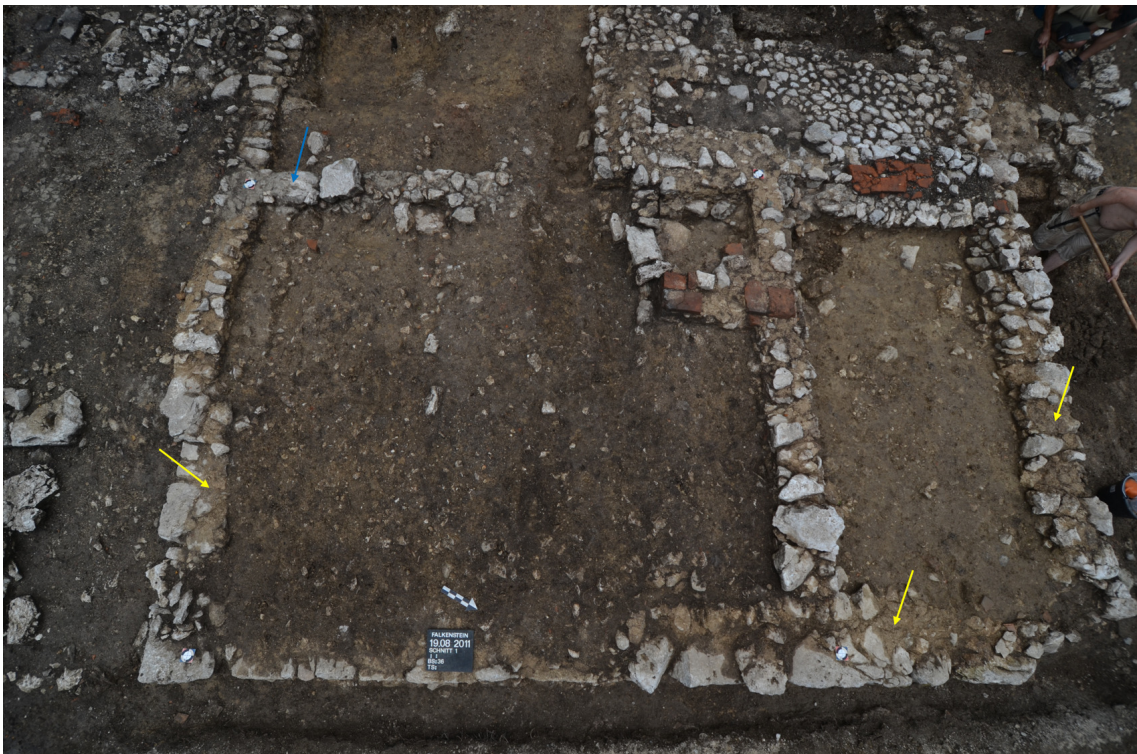
Fig. 7.4: A picture of parts of the hermitage showing a clear difference in mortar color when it is moist. The yellow arrows show the yellow mortar used in the construction of the first surrounding walls; the blue one indicates the grey mortar of wall 5 erected on top of wall 1 between Room 2 and 3.

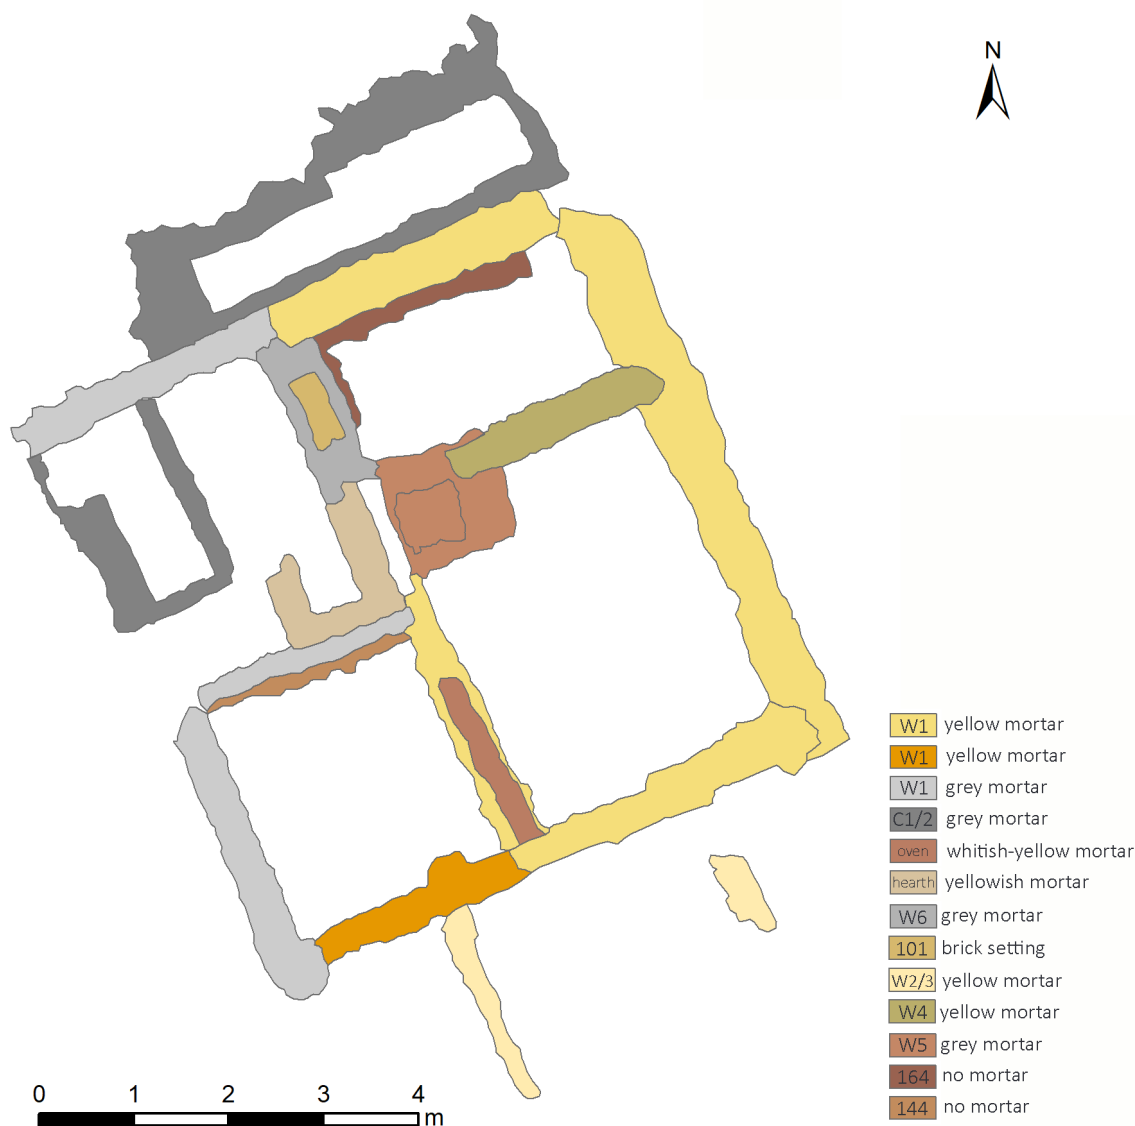
Fig. 7.5: Different mortar types (visually assessed) evidencing different construction phases.

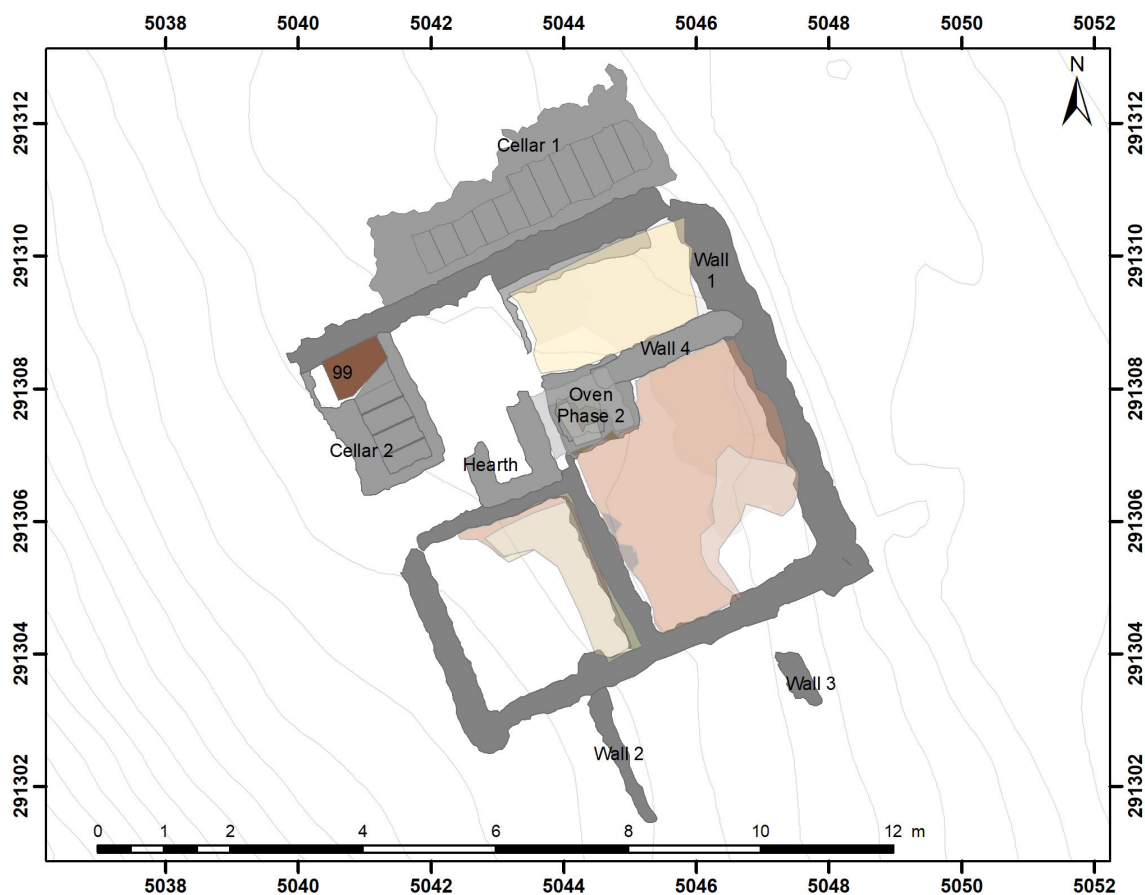
Fig. 7.8: Phase 5 evidencing the installation of a new trap door in room 4.

Phase 5 is defined by the remodelling of Room 4 with the installation of a trap door. (see Fig. 7.8) Wooden fragments of deposit 99 interpreted as a trap door in room 4 were sent to dendrochronological analysis. The results of the analysis of the wood undertaken by the University of Natural Resources and Life Sciences in Vienna provided information on the type and age of the wood. The fragments were identified as spruce; dendrochronological analysis resulted in a date of 1696 without bark edge.

there, this is a *terminus post quem*. The dendrochronological date suggests that the wood was cut in the early 18th century. As the trap should have held some weight, it is supposed that wood in good condition was preferred, and presumably, the installation of this trap door can be dated to the early 18th century or sometime later. There is no evidence for an earlier trap door; a preceding one is probable. Historic records additionally provide the information that in 1731 the floor of the hermitage was fouling, and it is proposed to use part of the proceeds of the inheritance of Hueber (12 Gulden) for repair works. The repair works had to be done as the hermitage still would host people up to at least 1812. Replacements of wooden floors easily could be done without leaving any archaeological evidence. Indeed, it has to be assumed that most of the repair works done in the hermitage are not visible in the archaeological record.

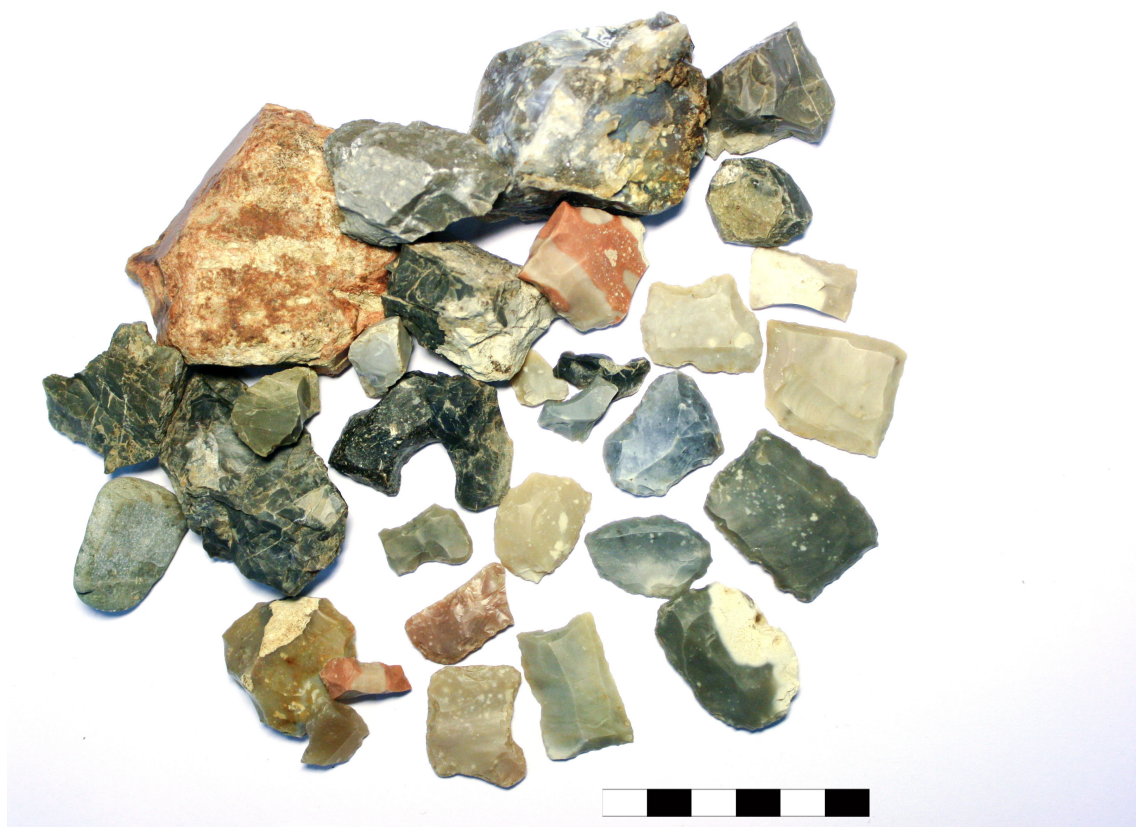
Fig. 7.10: Assortment of flint stones and gunflints found at the excavation.

The elongated and rectangular flints with two firing edges and a trapezoidal cross-section can be addressed as gunflints. (Fnr443-SU81, Fnr535-SU86, Fnr615-SU95, Fnr440-SU81 and a scattered find). These flints were primarily used from the 17th to the 19th century in the military and in civil use for flintlocks in weapons. Gunflints are made of flint stones and related stones; they were produced in large quantities in manufactories. The most known productions were located in Brandon (England) and Meusnes (France), but also other European countries (Denmark, Sweden, Poland, Ukraine, Belgium, Germany, Portugal, Spain, Italy, and Albania) had their productions.

In the flint lock mechanism, a spring-loaded hammer with the flint in its jaws is released by a trigger. It strikes a piece of steel creating sparks and ignites the priming powder, which in turn then ignites the black powder in the barrel, firing the arm. The flint lock mechanism though was also used in other fire-starting tools

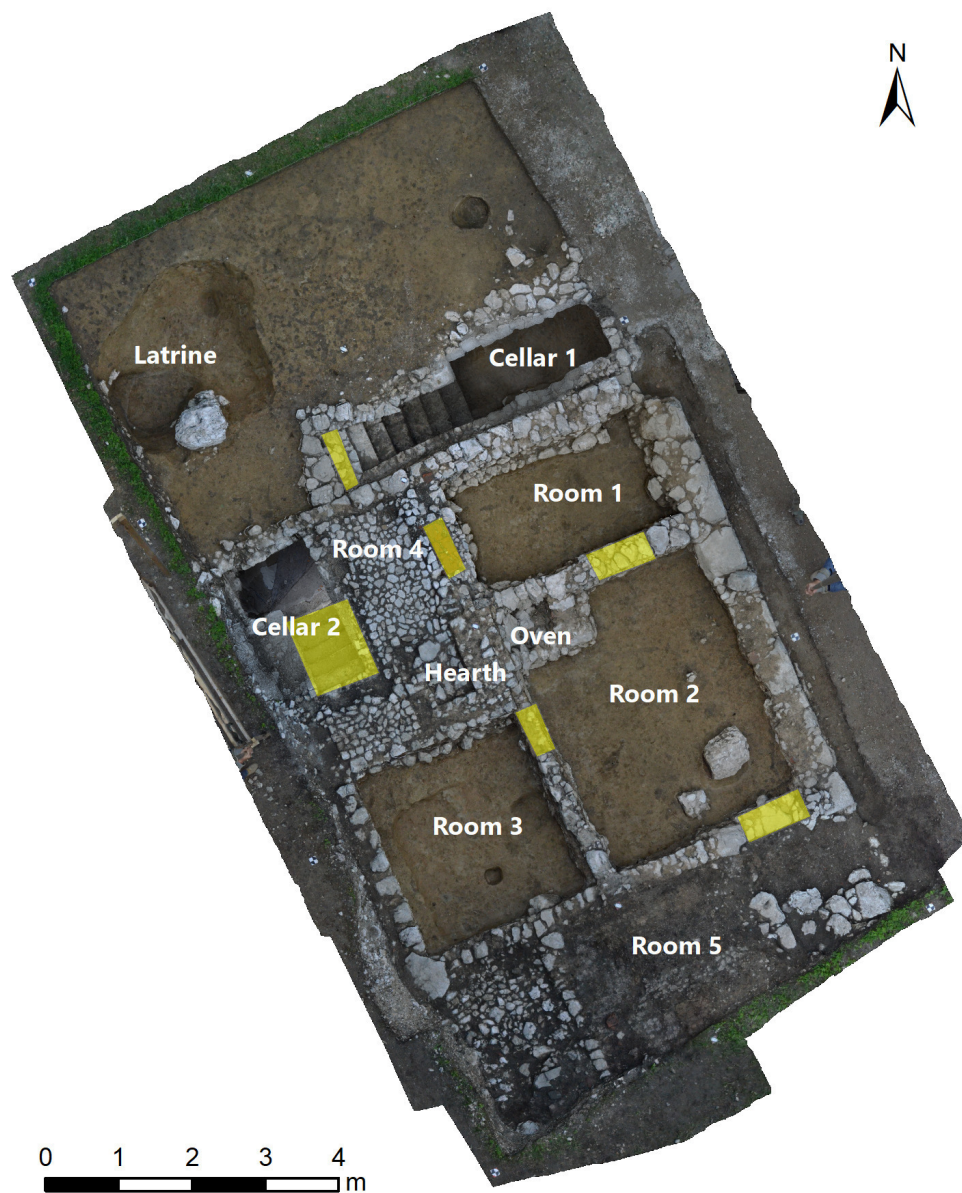
Fig. 8.1: The hermitage rooms are known from the two excavation campaigns and (possible) doorways between the rooms.

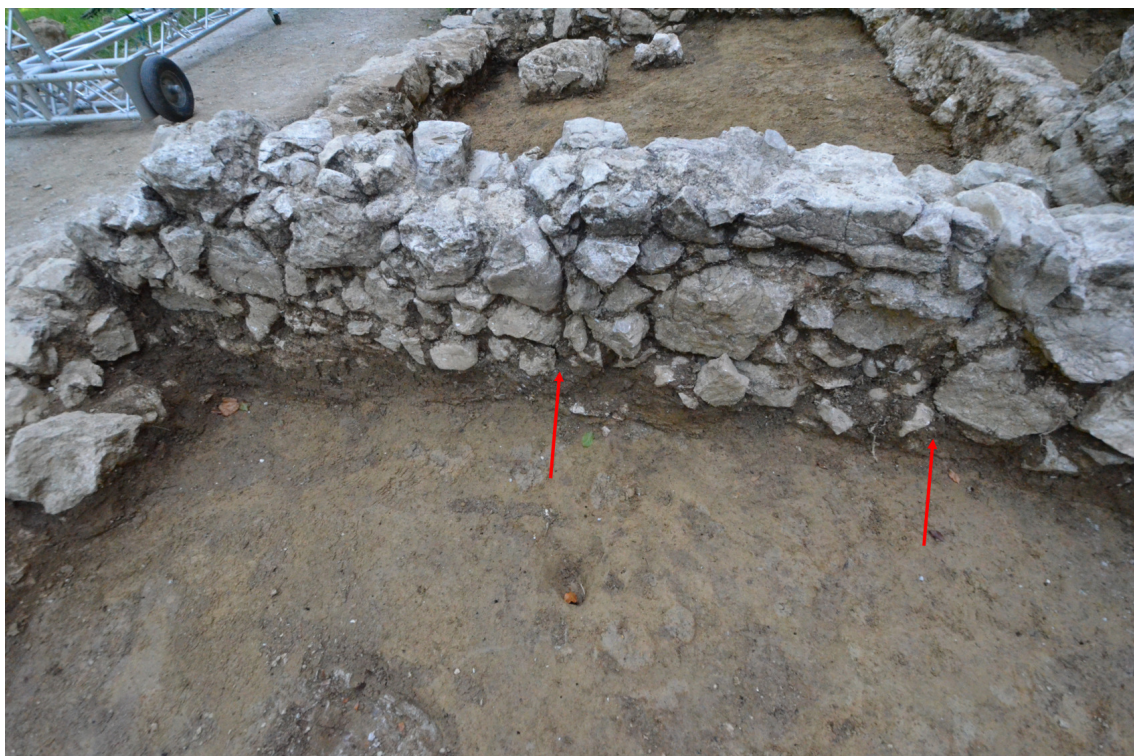
Fig. 8.2: Possible masonry seam in the wall between Room 1 and Room 2, that could indicate a door in an earlier phase.

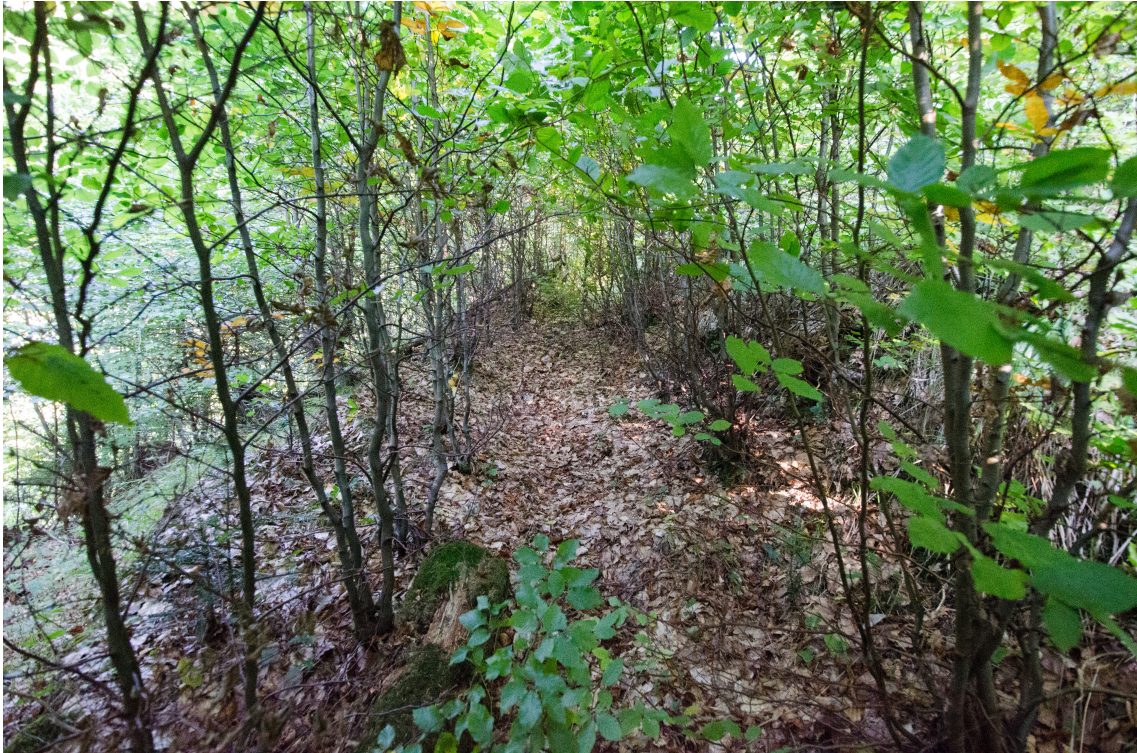
Fig. 8.11: Part of the historical pilgrimage path leading through the wood.

Nowadays, the historical course of the way can partially be traced in the field and can be seen in the topographical data (ALS). The course on the clearing itself can be estimated from historical illustrations and maps and more recently seen in photographic data.

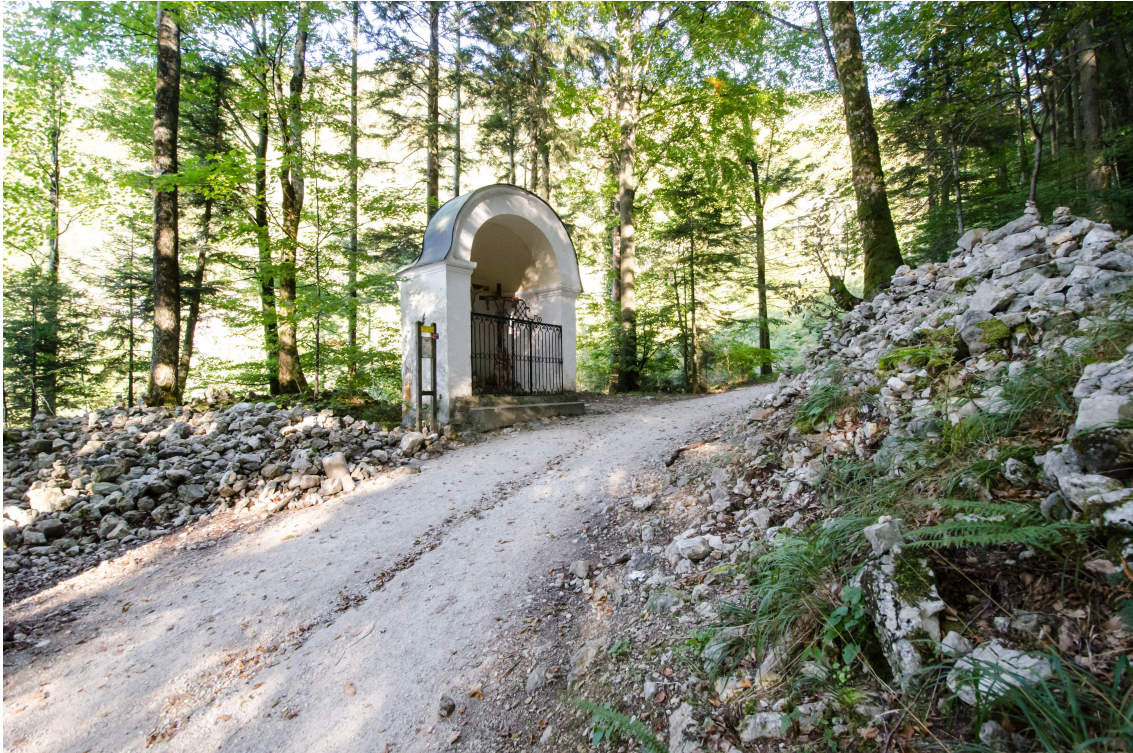
Fig. 8.12: The broadened recent pathway next to a chapel.

Analyzing the ALS data at the bay of Fürberg, the recent path is only slightly visible at the foot of the slope of the Schafberg to its east. It gets better visible in the terrain data again after some 150m, where it is visible as linear depression at the eastern edge of the canyon leading eastwards. It makes a turn south, crossing the stream, making another turn west and after some meters ( 30) south again. The following part to the south leads straight ahead until a rock face, where the path turns to the west leading alongside the rock face. It passes the Kreuzkapelle and continues until arriving in a slight curve at the clearing.
